REPORT DOCUMENTATION PAGE	READ INSTRUCTIONS BEFORE COMPLETING FORM		
	1. REPORT NUMBER 2. GOVT ACCESSION NO.	3. RECIPIENT'S CATALOG NUMBER		
9	Special Report 10-3 V			
	TITLE (and Sublitie)	5. TYPE OF REPORT & PERIOD COVERED		
16	THE DANISH DEEP DRILL			
्ध	Progress Report: February-March 1979	6. PERFORMING ORG, REPORT NUMBER		
	The second secon	o. PERFORMING ONG. REPORT NUMBER

This report was prepared by John Rand, Mechanical Engineer, Engineering and Measurement Services Branch, Technical Services Division, U.S. Army Cold Regions Research and Engineering Laboratory. The report covers work done for the National Science Foundation under Interagency Agreement NSF-DPP 78-17165.

The University of Copenhagen, Denmark, is developing a drill for obtaining ice cores from the Greenland Ice Sheet. The Division of Polar Programs of the National Science Foundation is sponsoring a major portion of this effort. As a part of the two-year testing program for the drill, Dr. Sigfus Johnsen and Mr. Jan Neilson tested the drill's downhole components at the U.S. Army Cold Regions Research and Engineering Laboratory in February and March 1979.

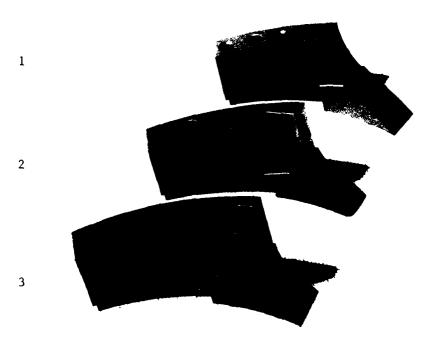
Fig. Al5.

Cutters. Cutter number 3 was used for most of the drilling at CRREL. $\,$
